**Flood Control Project Maintenance
Levee Inspections**

Maintenance Issue Types Only, Levee Inspection Report By Mile - Fall 2018

Reclamation District No. 2091 Chase

Waterway	Bank	Unit Miles	Inspection Start/End	Inspector
Unit No. 01 San Joaquin River	Right	7.46	09/26/2018 09/26/2018	Corey Fujitani

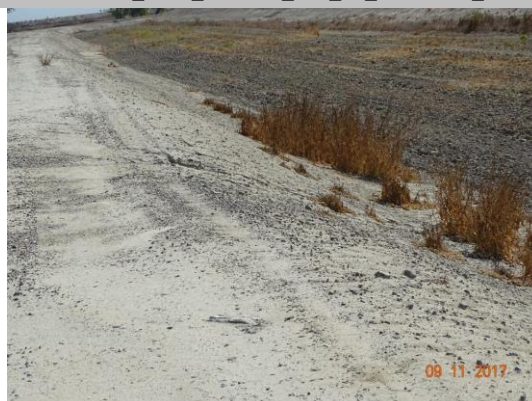
Photo 2 of 2 : FA_2018_RD2091_318_15_20180905_00016.jpg

LM Start	0.23	Rating **	A/W	Issue No.	15
LM End	0.23	Issue Type +	Ma	Location *	LS
Category	Earthen Levee			GPS Latitude/Longitude	
				Start	End
Item	Erosion / Bank Caving			37.541550 °	37.541550 °
				-121.096742 °	-121.096742 °
DWR ID	DWR_RD2091_01_s_2016_15				
Comment Code					
E1 : Note and monitor erosion site.					
Inspector Comment					
Caving on landward shoulder noted in 2017 possible collapsed pipe. Monitor for potential reoccurrence.

Looking northeast at the dip in the landside shoulder.

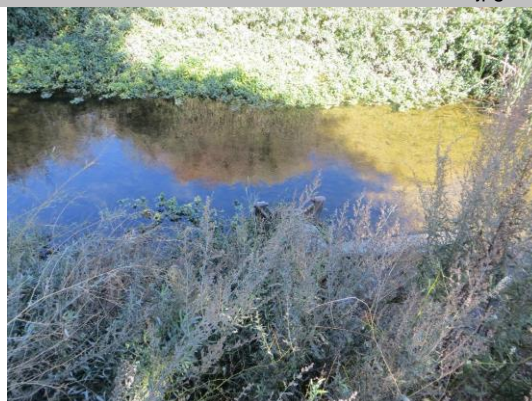
Photo 1 of 3 : UCIP_FA_2018_51639_38158.jpg

Comment Code						
Inspector Comment						
FS_ID:51639 DS_ID:23161 EP_NO: N/A Repair Type: Non-Urgent Crossing Status: Found UCIP Comments: 11/18/2016 Crossing has been downgraded from Urgent to Non-Urgent since the flap gate appears to fully close. According to Mike Alvez, this crossing is abandoned and the City of Modesto is working with CVFPB to authorize proper abandonment/removal. The City is working at finding funds to pay for proper abandonment/removal of all the drainage structures through this levee. (O. Magana - DWR UCIP)10/15/2013 Appears abandoned and if so should be done so properly. (W. Wylie - DWR UCIP) FIELD_STRUCT_DESC: *ABANDONED* 24-inch corrugated metal drainage pipe through the levee, 12 feet below the crown. Flap gate and concrete headwall on the waterside (WS) end. [Additional Reference(s): DWR Levee Log, 1992. USACE San Joaquin O&M Manual 6, September 1961, (HLM 0.64)]. FS Date: 11/18/2016

24-inch CMP on concrete headwall with flapgate on WS toe.

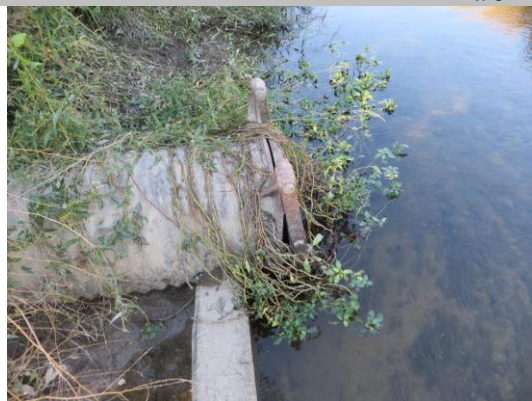
Photo 2 of 3 : UCIP_FA_2018_51639_38157.jpg

24-inch CMP on concrete headwall with flapgate on WS toe.

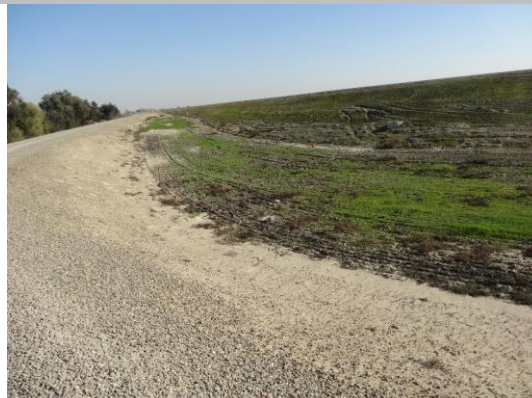
Photo 3 of 3 : UCIP_FA_2018_51639_76677.jpg

Comment Code						
Inspector Comment						
FS_ID:51639 DS_ID:23161 EP_NO: N/A Repair Type: Non-Urgent Crossing Status: Found UCIP Comments: 11/18/2016 Crossing has been downgraded from Urgent to Non-Urgent since the flap gate appears to fully close. According to Mike Alvez, this crossing is abandoned and the City of Modesto is working with CVFPB to authorize proper abandonment/removal. The City is working at finding funds to pay for proper abandonment/removal of all the drainage structures through this levee. (O. Magana - DWR UCIP)10/15/2013 Appears abandoned and if so should be done so properly. (W. Wylie - DWR UCIP) FIELD_STRUCT_DESC: *ABANDONED* 24-inch corrugated metal drainage pipe through the levee, 12 feet below the crown. Flap gate and concrete headwall on the waterside (WS) end. [Additional Reference(s): DWR Levee Log, 1992. USACE San Joaquin O&M Manual 6, September 1961, (HLM 0.64)]. FS Date: 11/18/2016

View of LS.

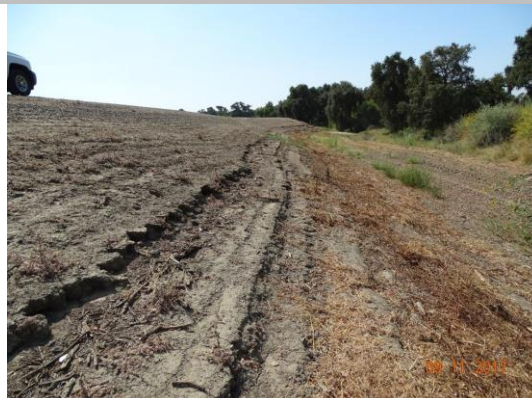
Photo 1 of 1 : FA_2018_RD2091_318_11_20180905_00008.jpg

LM Start	1.41	Rating **	A/W	Issue No.	11
LM End	1.43	Issue Type +	Ma	Location *	WS
Category	Earthen Levee			GPS Latitude/Longitude	
				Start	End
Item	Erosion / Bank Caving			37.531243 °	37.530896 °
				-121.106716 °	-121.106737 °
DWR ID	DWR_RD2091_01_f_2017_11				
Comment Code					
E2 : Schedule repair of erosion site prior to the next inspection.					
Inspector Comment					
Minor erosion on waterside toe.

Looking south at erosion on waterside slope.

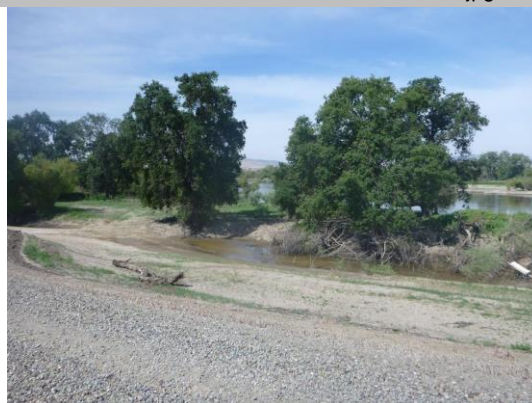
Photo 1 of 3 : LEVAL_FA_2018_132_1181.jpg

LM Start	1.41	Rating **	A/W	Issue No.	24	
LM End	1.44	Issue Type +	Ma	Location *		
Category	Supplemental			GPS Latitude/Longitude		
				Start		End
Item	2017 Storm Damage			37.531170 °		37.530760 °
				-121.106750 °		-121.106710 °
DWR ID	DWR_RD2091_01_f_2017_24					
Comment Code						
Inspector Comment						
Levee Evaluation Comments						
Description:						
Site ID No:132						
Site Designation:DWR_RD2091_01_R_2012_01						
Repair Type: Erosion						
Rating:Area of Concern						
Field Date:6/7/2017						
Notes: Wavewash erosion up to 12" deep at high water mark.

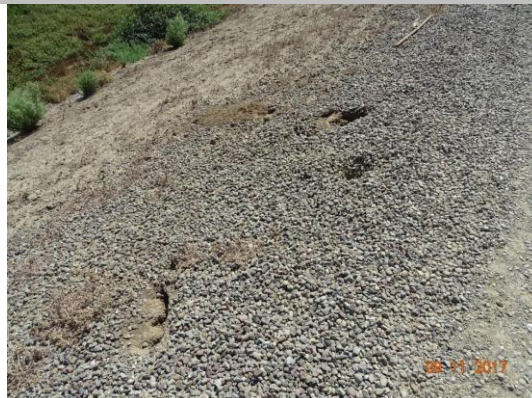
Photo 1 of 1 : FA_2018_RD2091_318_30_20180905_00028.jpg

Looking south at landside slope.

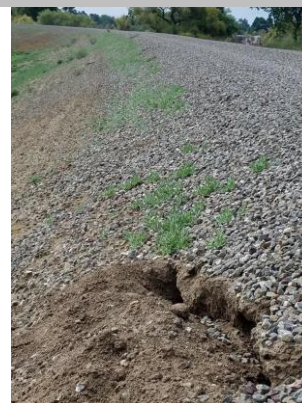
Photo 1 of 1 : FA_2018_RD2091_318_22_20180905_00021.jpg

LM Start	4.25	Rating **	A/W	Issue No.	22
LM End	4.25	Issue Type +	Ma	Location *	LS
Category	Earthen Levee			GPS Latitude/Longitude	
				Start	End
Item	Animal Control			37.501907 °	37.501907 °
				-121.082123 °	-121.082123 °
DWR ID	DWR_RD2091_01_s_2017_22				
Comment Code					
A3 : No rodents visible, but rodent burrows visible; need to backfill and compact or grout burrows.					
Inspector Comment					
Burrows no longer present. (2018)

Looking south at rodent activity on landward shoulder and slope.

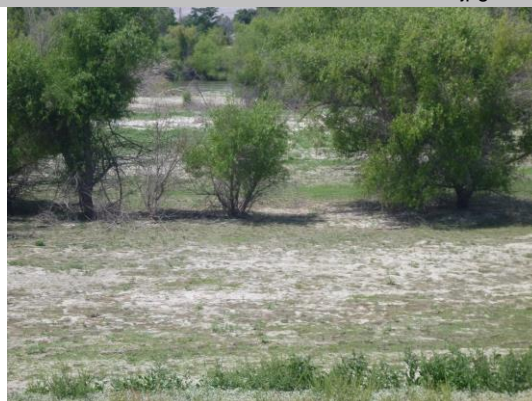
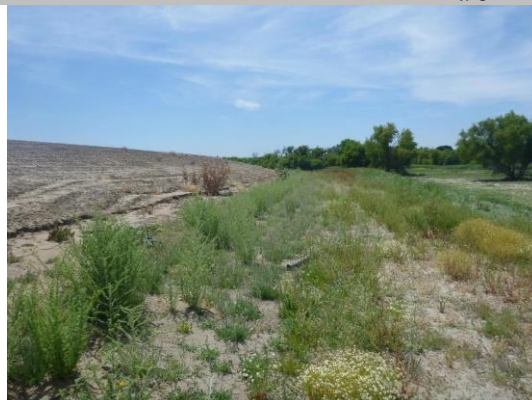
LM Start	4.83	Rating **	A/W	Issue No.	41
LM End	4.83	Issue Type +	Ma	Location *	
Category	Supplemental			GPS Latitude/Longitude	
				Start	End
Item	2017 Storm Damage			37.494300 °	37.494300 °
				-121.078300 °	-121.078300 °
DWR ID	DWR_RD2091_01_f_2017_41				
Comment Code					
Inspector Comment					
Levee Evaluation Comments					
Description:					
Site ID No:117					
Site Designation:LMA-37					
Repair Type: Erosion					
Rating:Area of Concern					
Field Date:6/7/2017					
Notes: Very minor erosion at toe of levee. Depth of erosion is 3" max.

LM Start	4.83	Rating **	A/W	Issue No.	41 (cont)	
LM End	4.83	Issue Type +	Ma	Location *		
Category	Supplemental			GPS Latitude/Longitude		
				Start		End
Item	2017 Storm Damage			37.494300 °		37.494300 °
				-121.078300 °		-121.078300 °
DWR ID	DWR_RD2091_01_f_2017_41					
Comment Code						
Inspector Comment						
Levee Evaluation Comments						
Description:						
Site ID No:117						
Site Designation:LMA-37						
Repair Type: Erosion						
Rating:Area of Concern						
Field Date:6/7/2017						
Notes: Very minor erosion at toe of levee. Depth of erosion is 3" max.

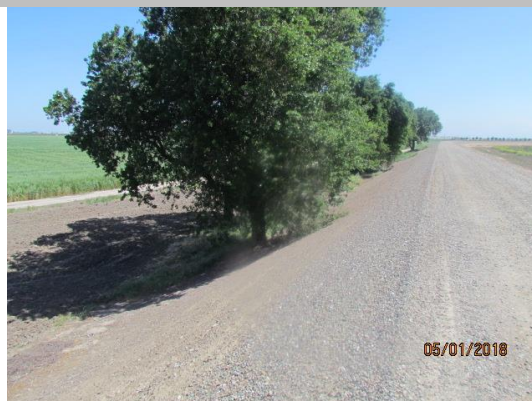
Photo 1 of 1 : FA_2018_RD2091_318_12_20180905_00009.jpg

Looking southeast at untrimmed tree at landward toe. (Spring 2018)

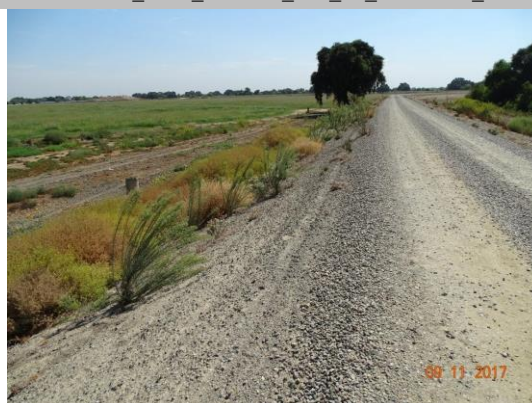
Photo 1 of 1 : FA_2018_RD2091_318_36_20180905_00029.jpg

LM Start	6.23	Rating **	M	Issue No.	36
LM End	6.27	Issue Type +	Ma	Location *	LS
Category	Earthen Levee			GPS Latitude/Longitude	
				Start	End
Item	Vegetation			37.485724 °	37.485234 °
				-121.058443 °	-121.058032 °
DWR ID	DWR_RD2091_01_f_2017_36				
Comment Code					
V2 : Remove the wild growth other than native grasses from the levee slopes.					
Inspector Comment

Looking southeast at landside slope.

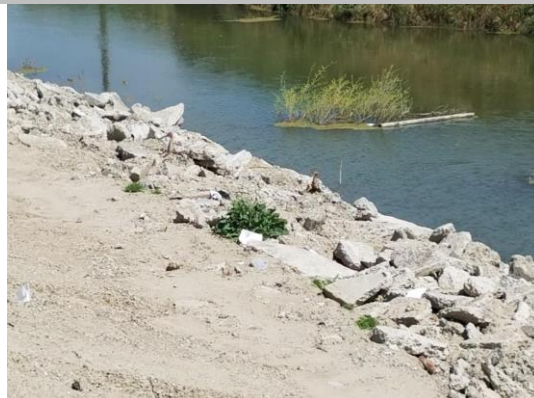
Photo 1 of 3 : FA_2018_RD2091_318_8_20180905_00001.jpg

LM Start	7.42	Rating **	U	Issue No.	8
LM End	7.45	Issue Type +	Ma	Location *	LS
Category	Earthen Levee			GPS Latitude/Longitude	
				Start	End
Item	Erosion / Bank Caving			37.479308 °	37.478998 °
				-121.044708 °	-121.044660 °
DWR ID	DWR_RD2091_01_s_2017_8				
Comment Code					
E2 : Schedule repair of erosion site prior to the next inspection.					
Inspector Comment					
Repaired area with concrete containing rebar. Need to remove rebar.

Looking northeast at concrete rubble with rebar at landward toe next to canal.

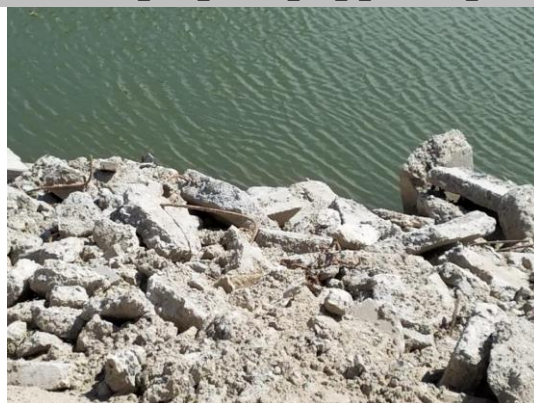
Photo 2 of 3 : FA_2018_RD2091_318_8_20180905_00002.jpg

Looking east at concrete rubble with rebar at landward toe next to canal.

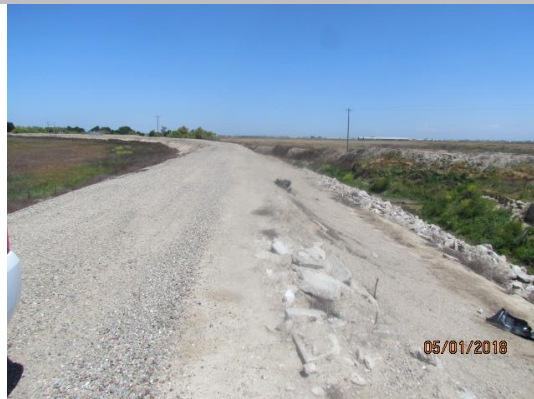
Photo 3 of 3 : FA_2018_RD2091_318_8_20180905_00003.jpg

Looking east at repaired site on waterward slope and toe. (Spring 2018)

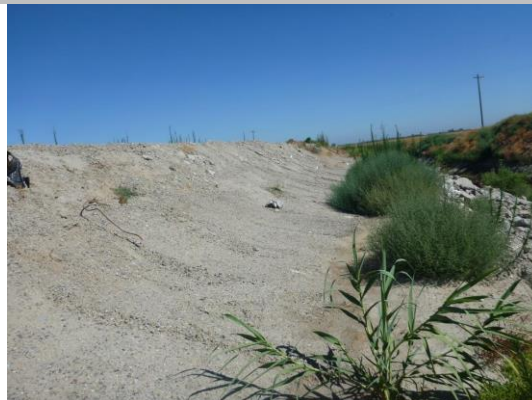
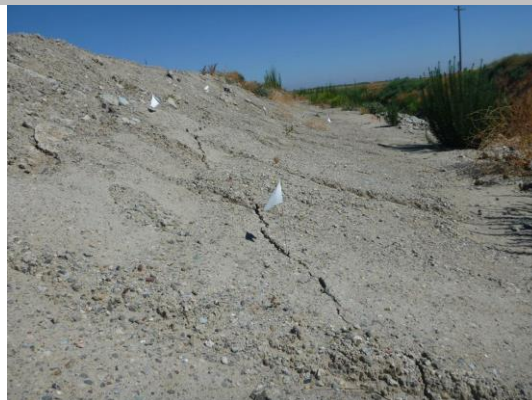
LM Start	7.45	Rating **	A/W	Issue No.	23
LM End	7.45	Issue Type +	Ma	Location *	
Category	Supplemental			GPS Latitude/Longitude	
				Start	End
Item	2017 Storm Damage			37.479000 °	37.479000 °
				-121.044000 °	-121.040000 °
DWR ID	DWR_RD2091_01_f_2017_23				
Comment Code					
Inspector Comment					
Levee Evaluation Comments					
Description:Sloughing at Mile 7.59 of the San Joaquin River					
Site ID No:473					
Site Designation:LMA-300					
Repair Type: Erosion					
Rating:Area of Concern					
Field Date:7/20/2017					
Notes: Concrete rubble was installed here during the storms after noticing cracks and sloughing. It has rebar sticking out and needs to be replaced with clean rip rap. Responibility is grey here because TID maintains channel and placed concrete during storm.

LM Start	7.45	Rating **	A/W	Issue No.	23 (cont)
LM End	7.45	Issue Type +	Ma	Location *	
Category	Supplemental			GPS Latitude/Longitude	
				Start	End
Item	2017 Storm Damage			37.479000 °	37.479000 °
				-121.044000 °	-121.040000 °
DWR ID	DWR_RD2091_01_f_2017_23				
Comment Code					
Inspector Comment					
Levee Evaluation Comments					
Description:Sloughing at Mile 7.59 of the San Joaquin River					
Site ID No:473					
Site Designation:LMA-300					
Repair Type: Erosion					
Rating:Area of Concern					
Field Date:7/20/2017					
Notes: Concrete rubble was installed here during the storms after noticing cracks and sloughing. It has rebar sticking out and needs to be replaced with clean rip rap. Responibility is grey here because TID maintains channel and placed concrete during storm.
